MEASUREMENT OF FLYING QUALITIES OF A DEHAVILLAND

MOSQUITO F-8 AIRPLANE (AAF NO. 43-334960)

I - LATERAL AND DIRECTIONAL STABILITY

AND CONTROL CHARACTERISTICS

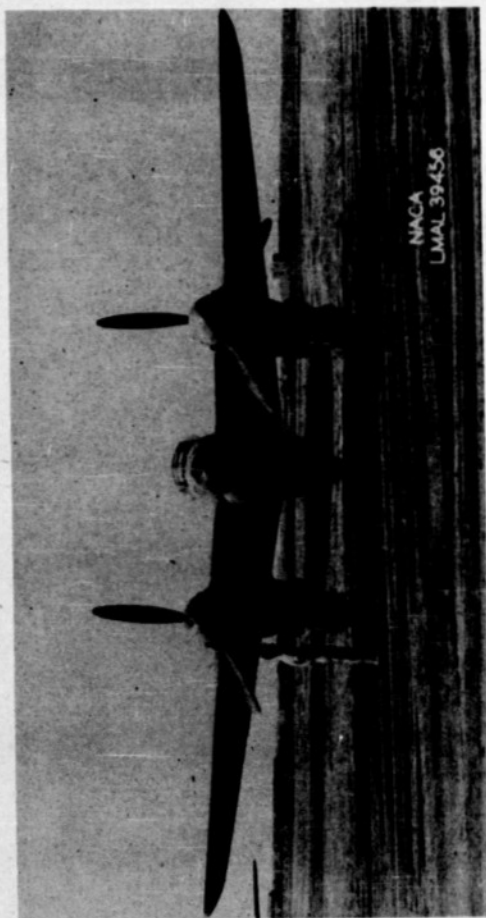
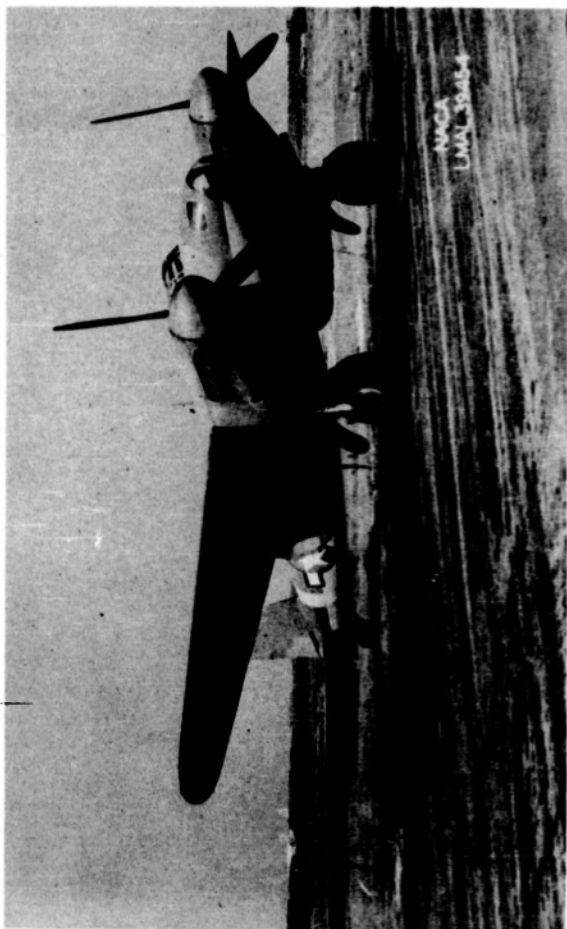
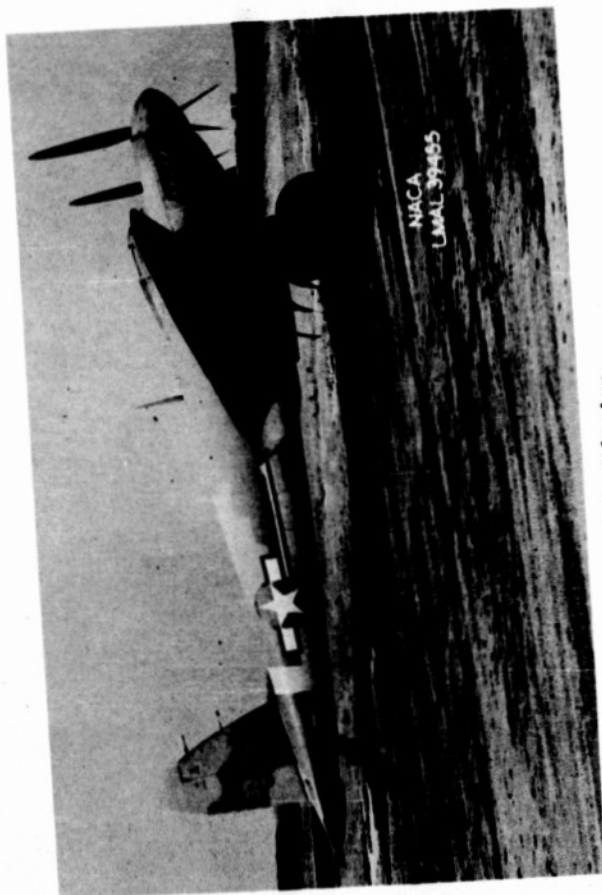
Figure 1.- Photographs of a DeHavilland Mosquito F-8 airplane.

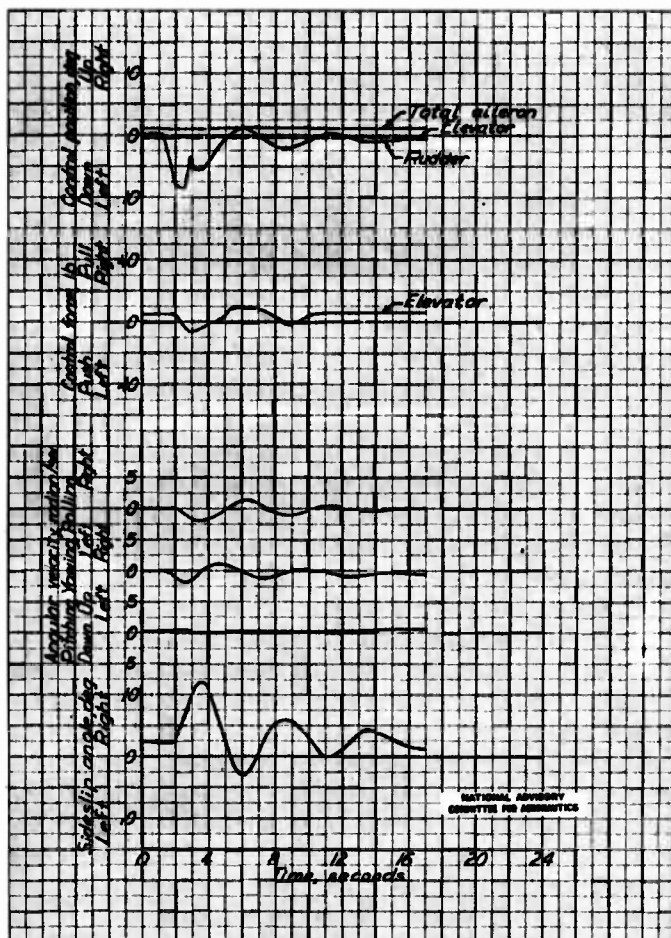
a. Left stick and release.
Figure 7. - Level oscillations in the clean condition
at 180 miles per hour with power for level
flight (2050 rpm, 5 pounds boost), shutters
closed, De Havilland Mosquito P-3 airplane.

b. Right kick and release.
Figure 7. - Continued.

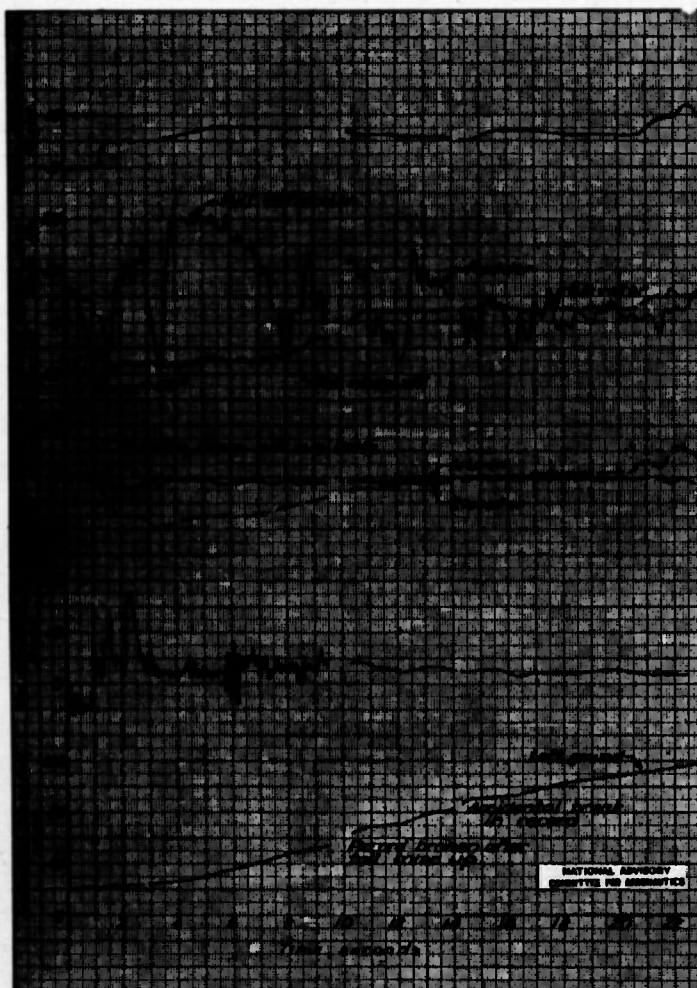
Figure 18. - Time history of a take-off using 10 pounds boost at 3000 rpm, shutter open, flaps up, center of gravity at 25 percent M.A.G., Develand No. 10-2 airplane.

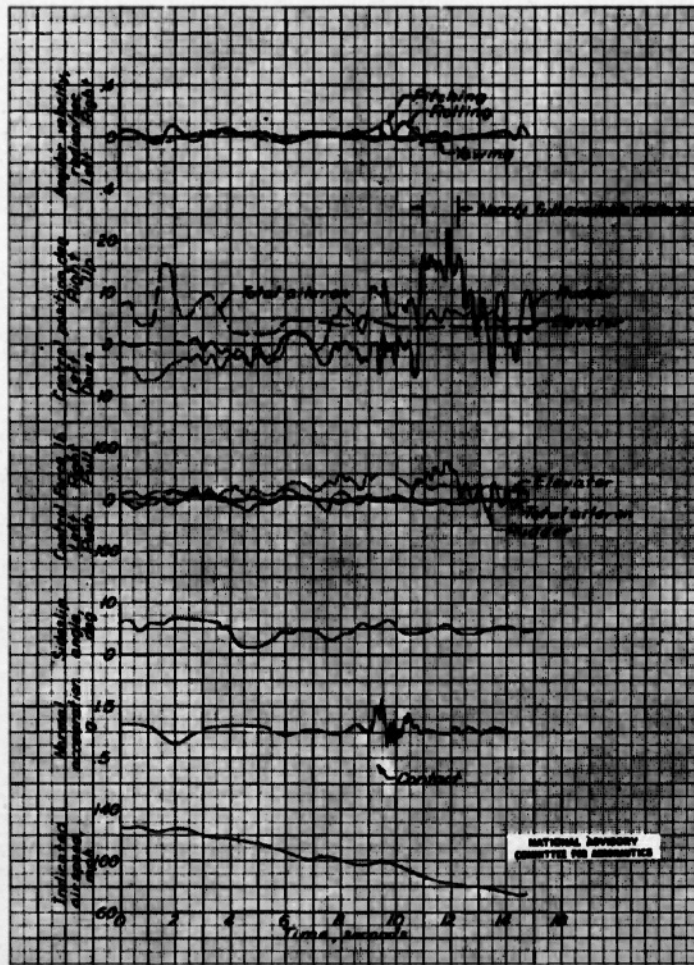
Figure 19. - Time history of a landing with the center of gravity at 36 percent M.A.C., flaps down, landing gear down, engine idling. Do-Neville's No. 1000 F-2 airplane.
